Innovative Solutions for Urban Pigeon Problems

Case Study

HAMILTON CITY COUNCIL

Administration Building

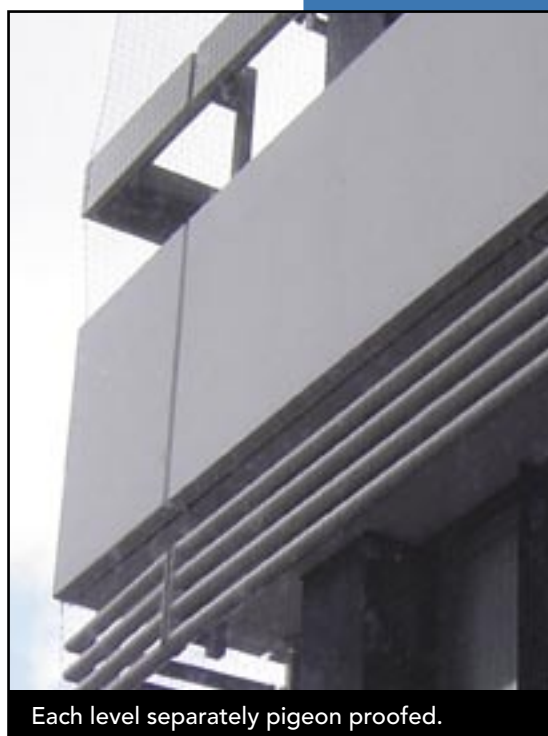
Each level separately pigeon proofed.

This BirdNet pigeon proofing project comprised imported black knotted industrial polyethylene bird net (50mm mesh) fitted at every mesh to proprietary 2mm braided 306 grade stainless wire and fittings. This needed to be done with care so that the stretched net pattern was consistently neat on both building faces and, provided total pigeon exclusion to all netted areas.

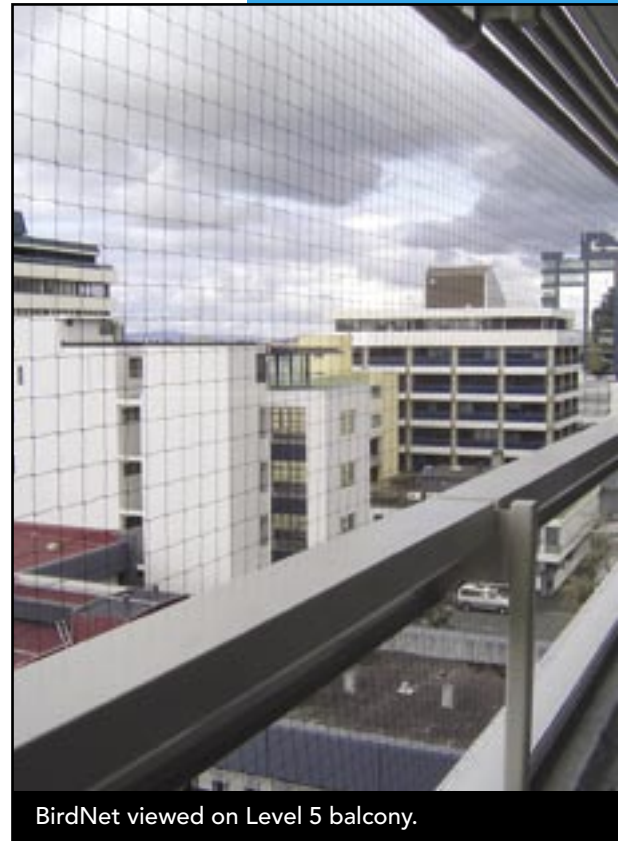
BirdNet viewed on Level 5 balcony.
